Roslyn Landmark Society
Annual House Tour Guide.

A Manual of Pre-Revolutionary Houses.

ARCHITECTURAL ANALYSIS REPORT

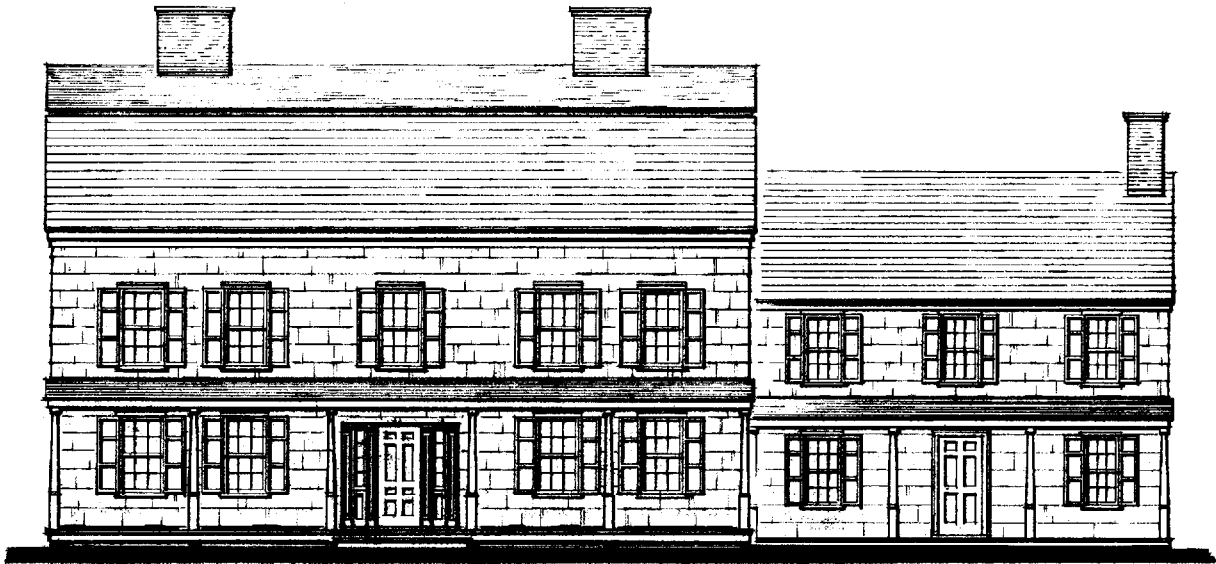
WILLOWMERE
Conjectural elevation of principal (south) facade circa 1850,
at which time the house was called "Clifton".

EXTERIOR: As it stands today, the house appears to be typical large shingled house of the mid-18th century with a six-bay facade and a high gambrel roof. From the beginning it appears to have had an ell at its east end, and the house so appears in the lithograph in Thompson's "History of Long Island, 2nd Ed., 1843". The original full cellar, with rubble walls to the sills and stone arches under the chimneys, still survives in excellent condition. The original wide (12" and more) yellow pine floor boards may still be seen from the cellar, resting on the original beams. These all are covered on the ground floor interior by 6" oak flooring of the 20th century. Part of the south cellar wall, under the present ell, is also rubble, but the remaining walls are brick indicating that the original ell was substantially altered, probably by Admiral Ward as full brick foundations did not appear in Roslyn until the second half of the 19th century. At present the principal (south) facade has six bays in place of the original five, but the southeast corner does not rest on the original rubble foundation but on a later brick foundation (Admiral Ward's alteration). In addition the shingles in the area of the sixth bay obviously are newer than the rest. All the shingles are butt-nailed and have a 12" exposure. The rear (north) facade remains five bays in width. The original water table with a rounded upper edge also survives along the south front. The dormer windows are 20th century and were added during the Curtis alteration. The facade windows all are 6/6, many of them original. The louvered shutters date from Admiral Ward's Victorianization of the late 19th century. Hopefully, illustrations of the house during all its three periods will be available for examination during the tour. The architects for the Curtis alteration were Peabody, Wilson & Brown. The present front porch was installed by Mr. Curtis to replace the great Victorian verandahs and porte cochere which had been added by Admiral Ward. The present porch is a replica of an 18th century porch of Salem, Mass. origin. The 8-panel front door and the doorway are in the Greek Revival style and utilize Tuscan mouldings and sidelights and are a part of the Cairns' alteration of 1839. The original (1839) hardware and lock on the front door still survive. The latter bears the stamped mark of Mackrell & Richardson, New York, on its bolt as do most of the other locks in the house. This firm of locksmiths worked on Houston Street, New York City, from 1835 to 1868.
