Roslyn Landmark Society Annual House Tour Guide.

Twenty-Fifth Anniversary Year

June 7, 1986
10:00–4:00

26TH ANNUAL HOUSE TOUR

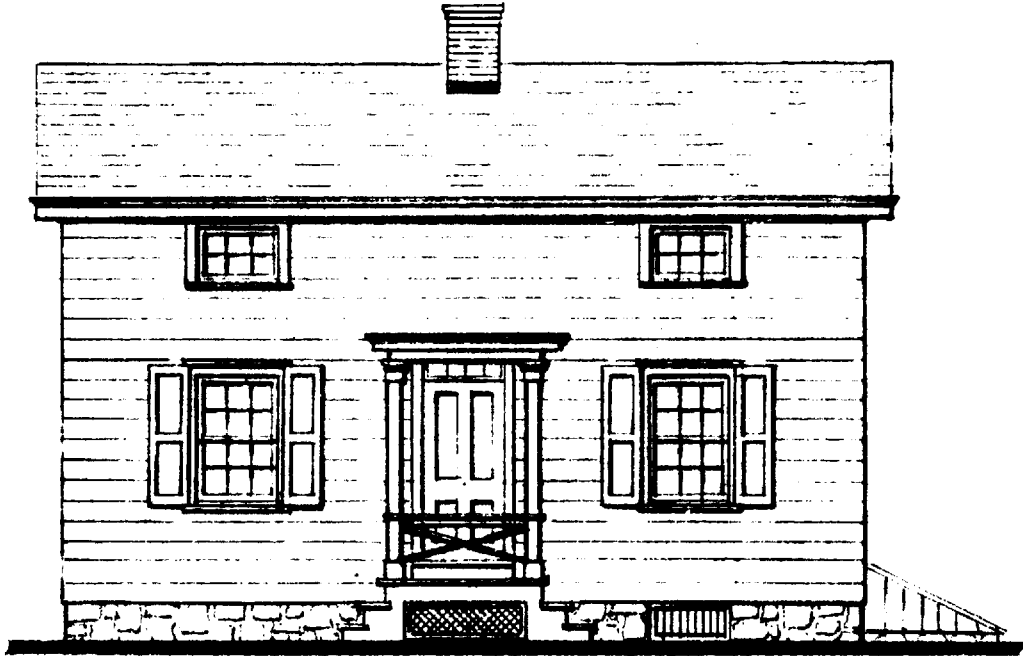
Samuel Dugan, Jr. House, ca. 1835, as it appeared when built.
Guy Ladd Frost, Artist.

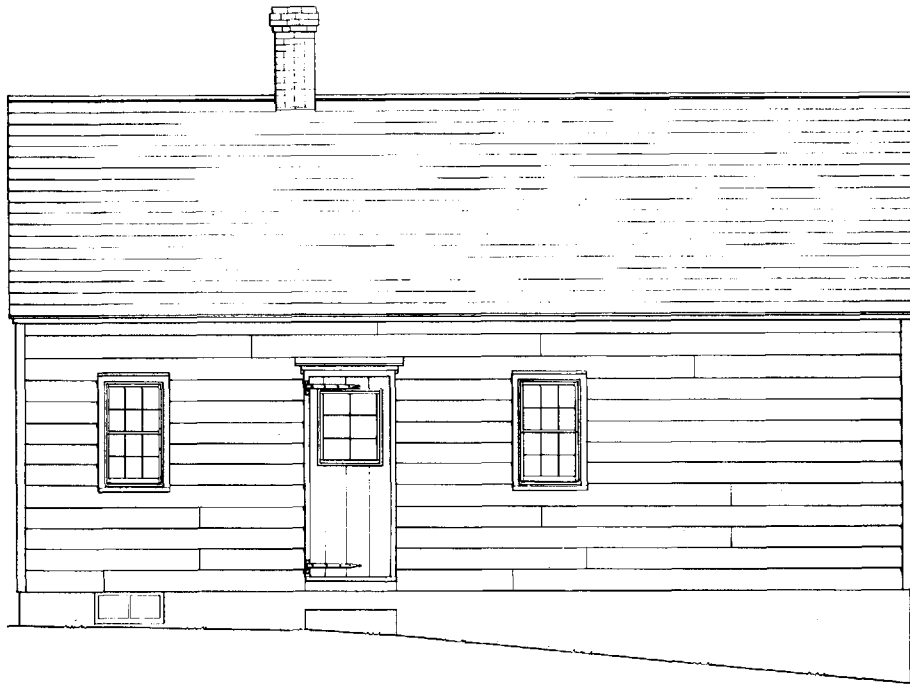
Captain Jacob Mott Kirby Storehouse, 1835–45, as it appeared prior to 1985 restoration. South Elevation.
John R. Stevens, Artist

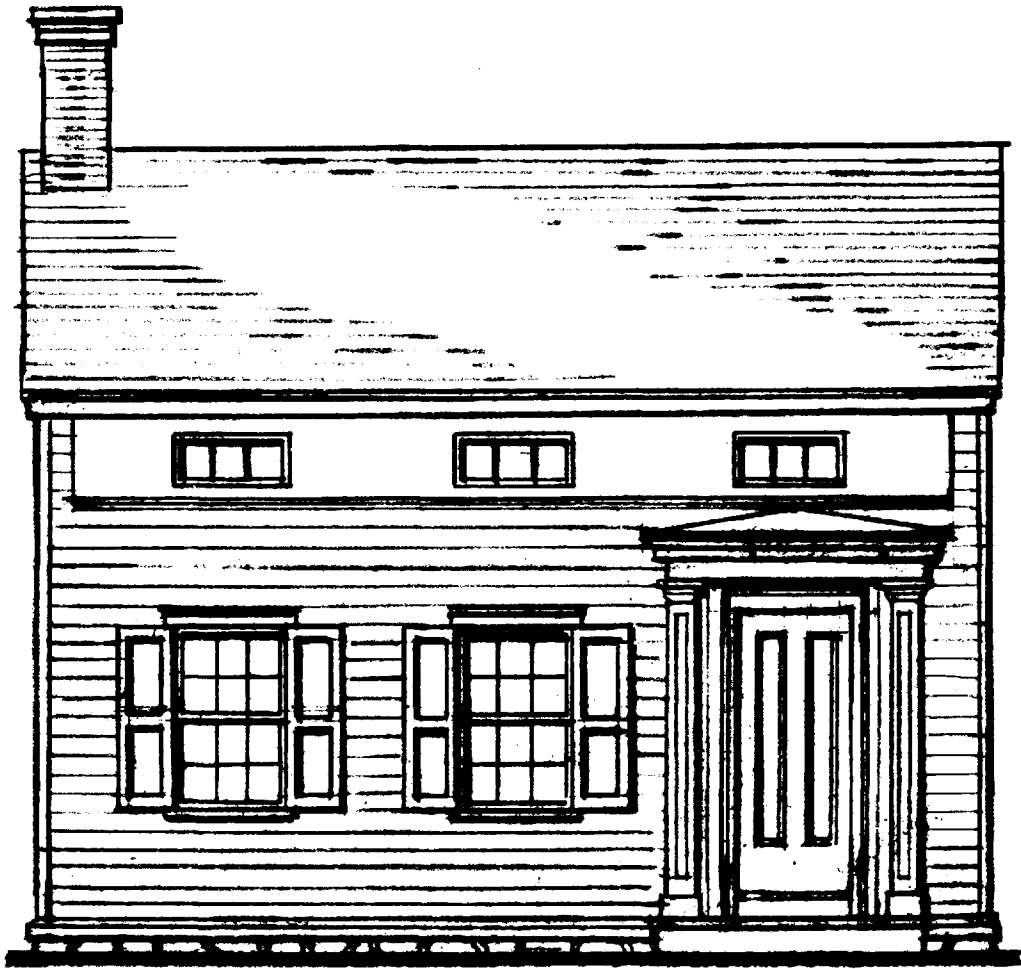
Smith Hegeman House, ca. 1845
Drawn by Guy Ladd Frost, A.I.A.

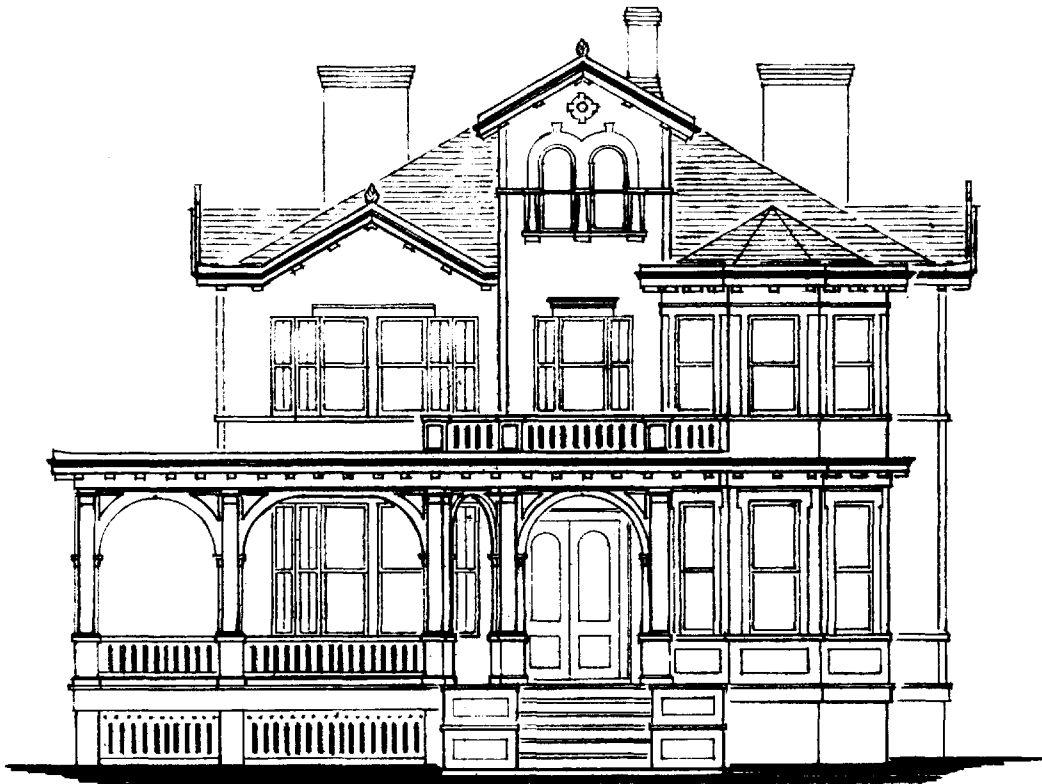
G. W. Denton House, ca. 1875
Drawn by Guy Ladd Frost, A.I.A.

Besides the 3-bay by 3-bay, hipped-roof main block of the house, there are two, two-storey rectangular wings which occupy the north half of the west front. The smaller of these is to the west of the larger. Both have half of a hipped roof. The larger provides ground floor space for the kitchen and the smaller for the early laundry. The south half of the west front is occupied by a single-storey, pent roof wing which provides space for the pantry. There is a small addition to the west of this one-storey wing, but this has a concrete foundation and is later work.

The house has a full brick foundation, laid in common bond. The cellar has three-light windows and a small brick-cheeked bulkhead on the south. The clapboard exposure is five inches to the weather. The house has moulded corner-boards appropriate for its period and has a magnificently contoured water-table beneath the lower course of clapboards. The window sash in the east and south fronts of the main block are of the 1/1 type. The east and south fronts were the most visible and, therefore, were fitted with more "modern" sash. The remaining windows were fitted with 2/2 sash which was less expensive and would not be seen anyway. All the windows are fitted with broad, crosstetted exterior facings and vigorous drip-caps, some of which are moulded. There is a projecting window string-course, beneath the ground floor windows, which forms their sills. All but the bay windows originally were fitted with louvered shutters. These are not in place,
