Roslyn Landmark Society
Annual House Tour Guide.

32nd Annual Tour

June 6, 1992

The Van Nostrand-Starkins House

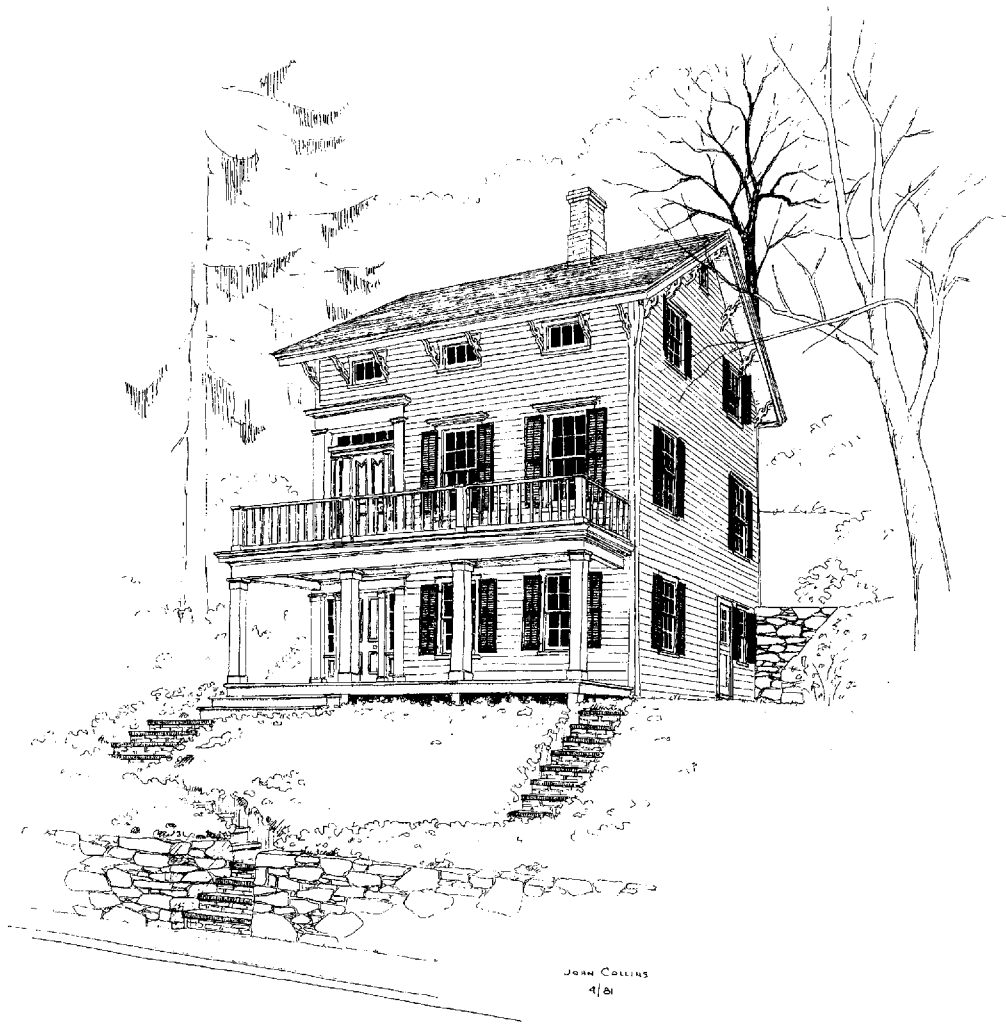
John S. Wood House as it appeared when built, circa 1855
Drawing by John Collins.

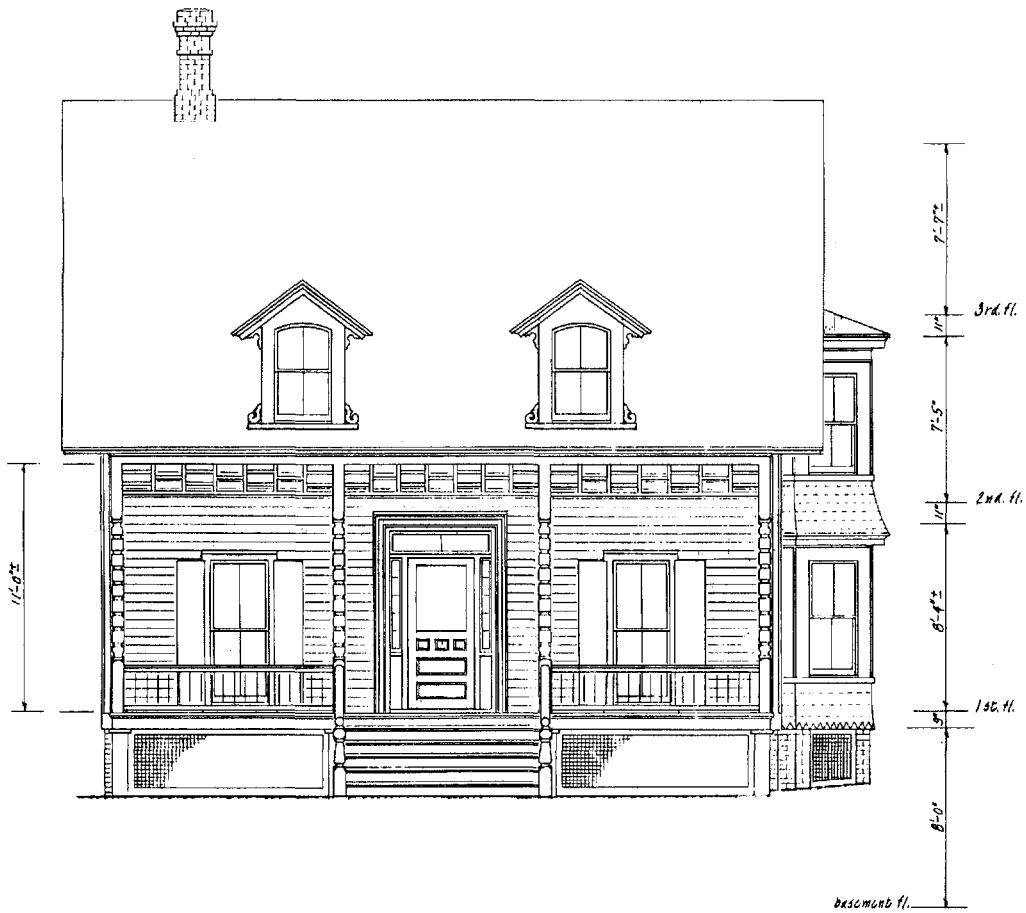
EAST ELEVATION

John F. Remsen House, 1885, as it appeared when built except that the inner core of the doorway was changed and the second storey of the bay window was added, ca. 1905.

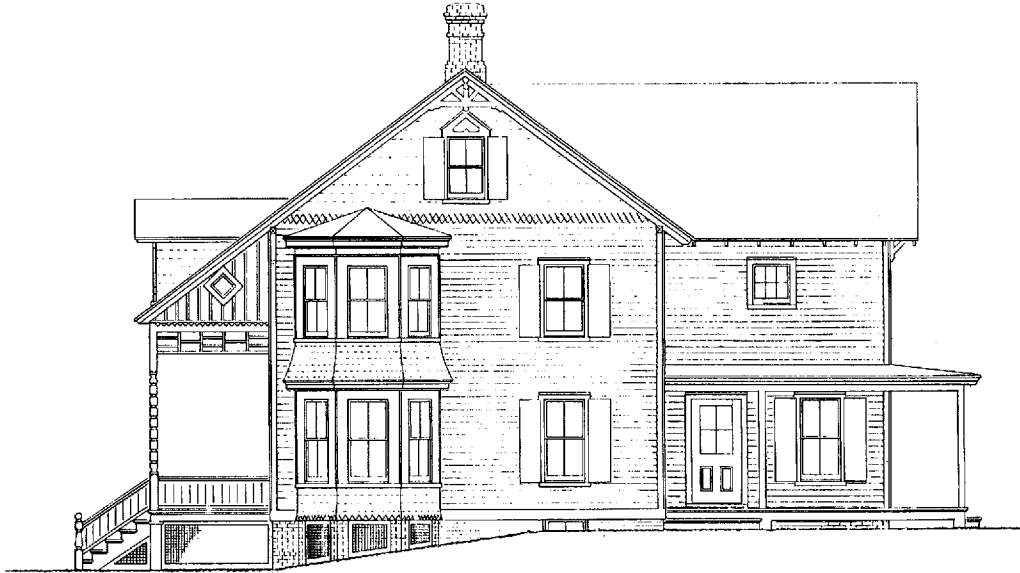
NORTH ELEVATION

John F. Remsen House, 1885, as it appeared in Phase III, ca. 1905.
Drawing by John R. Stevens.

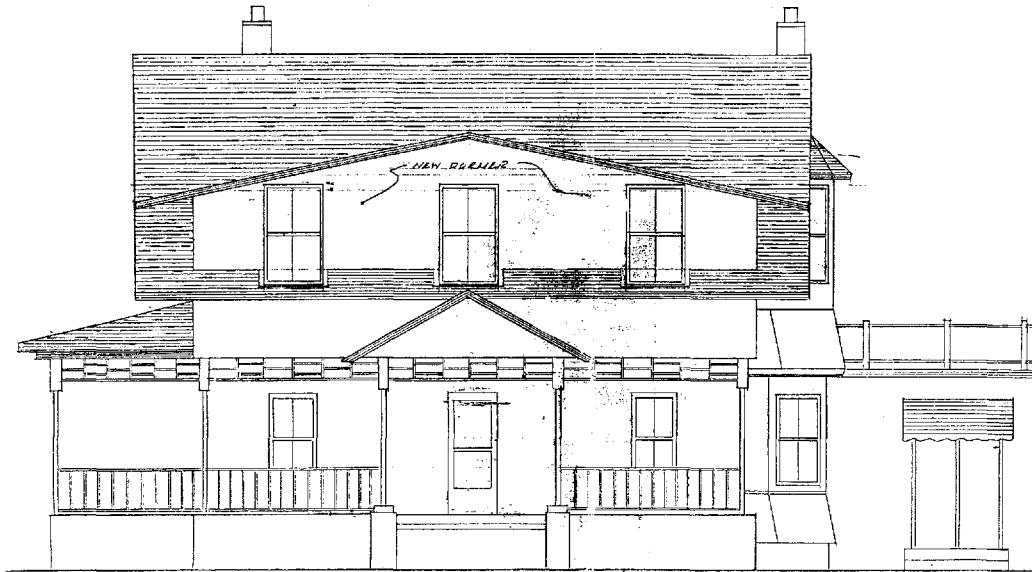
John F. Remsen House
 Construction drawing for end of Phase IV, 1967.
 A.J. Assocs., Huntington.

The changes included in phase IV were probably initiated c. 1935 and continued until the final alteration in 1965. The first change occurred c. 1935 when the house was sided with asbestos shingle siding, over both clapboards and decorative shingling. The new siding required the removal of much of the decorative trim and molded window drip caps. The wooden porch balustrade was replaced with a wrought iron railing. An exterior chimney stack was built against the north side of the house. More work occurred c. 1956, when the kitchen ell porch was enclosed, and a one story wing was added to the north. This wing was flat roofed, had large glass windows on three sides, and a very large masonry chimney located on the west facade. Aluminum awnings graced two of the entrances. In 1965, the interior was largely stripped of its historic finishes, and a large shallow gable dormer replaced the two front dormers and extended the full width of the roof. This extended the east chambers by the full depth of the front porch. The original attic staircase was re-located to run continuously with the principal staircase. A steel beam was run from north to south, above the first floor ceiling, which replaced the north-south beam in the dining room as well as the hallway doorway and wall separating the front and rear parlors which had been removed early in Phase III.

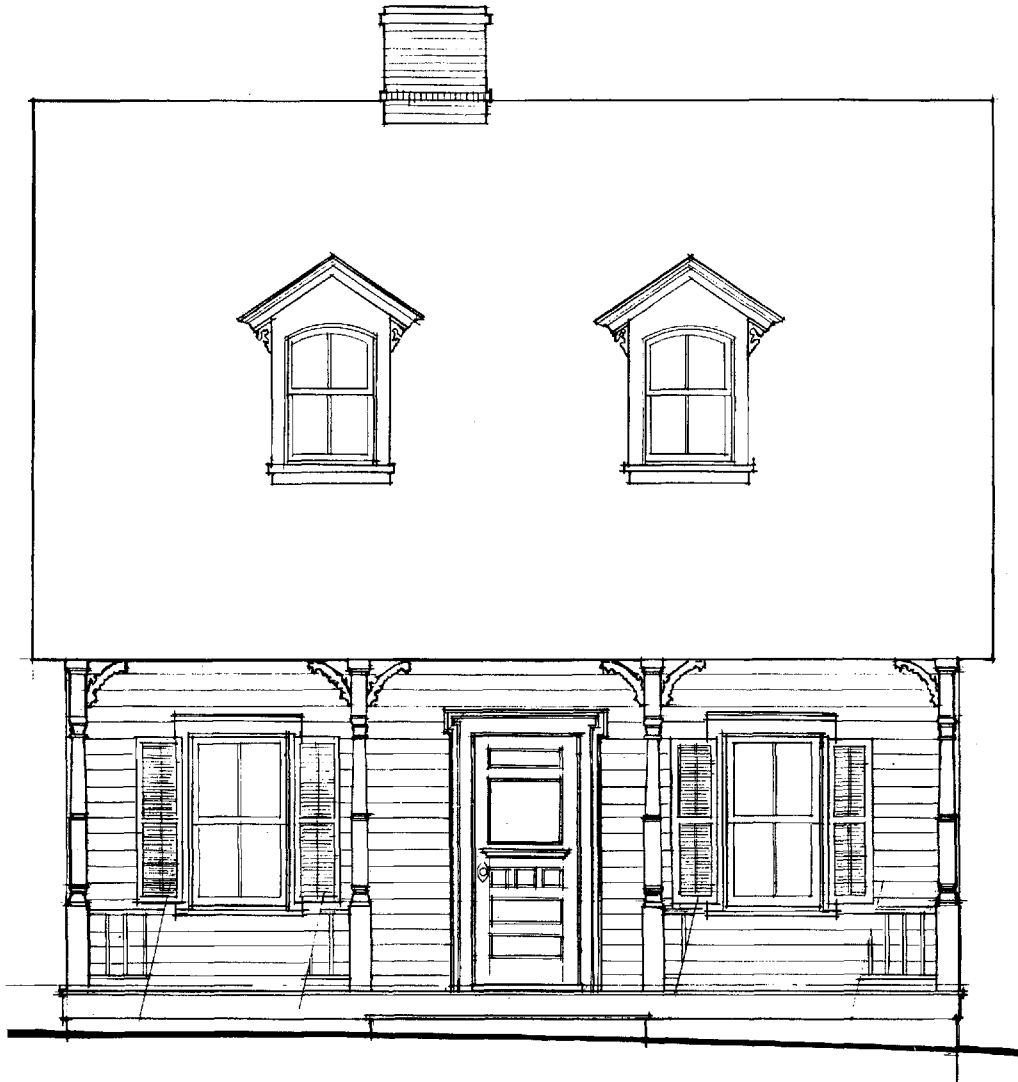
Estella M. Seaman House #1
South Elevation as It Appeared when Built.
Drawing by John P. Hawkins.

The small house which is the subject of this article is three bays wide and has a central doorway. It has a gable-ended roof which was shingled originally, the ridge of which runs from east to west, parallel to the road. It was built upon a brick foundation, laid in American bank, which comprises the exterior walls of the entire ground floor. The house is built into a steep hillside and this "basement" floor is above grade on all sides but the south. Above the brick foundation the house is clapboarded, has plain corner-boards and a plain water-table. Almost all the original sash were 2/2 and set in cases having narrow unmoulded exterior facings and plain drip-caps. The second and third storey windows of the east and

The exterior remained in its original configuration apart from re-roofing, painting, and the fitting of a new front door and a new chimney, as the result of control of the Historic District Board of the Incorporated Village of Roslyn. However, most of the original 2/2 sash were replaced with 1/1 metal-framed sash on the second and third storeys, without Historic District Board approval. The original wood-framed sash which survived were fitted with metal window raising tracks which replaced the sash-weights and cords.

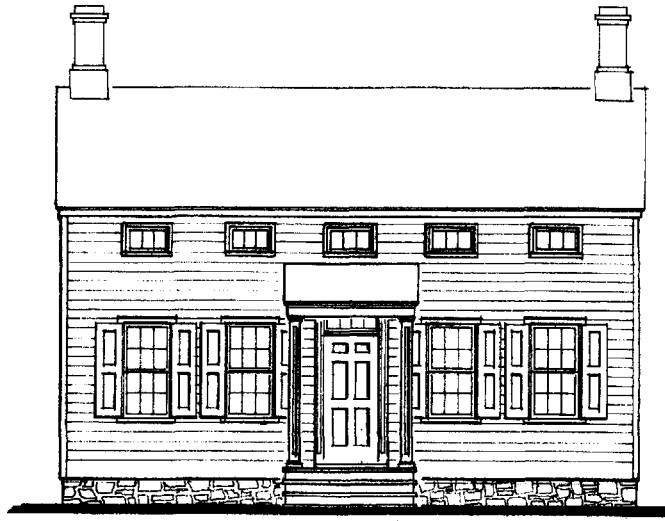
“Springbank” (ca. 1835). Conjectural, but probably accurate drawing of its appearance when built, a typical Roslyn late Federal-Greek Revival transitional house. Drawing by Guy Ladd Frost, A.I.A.

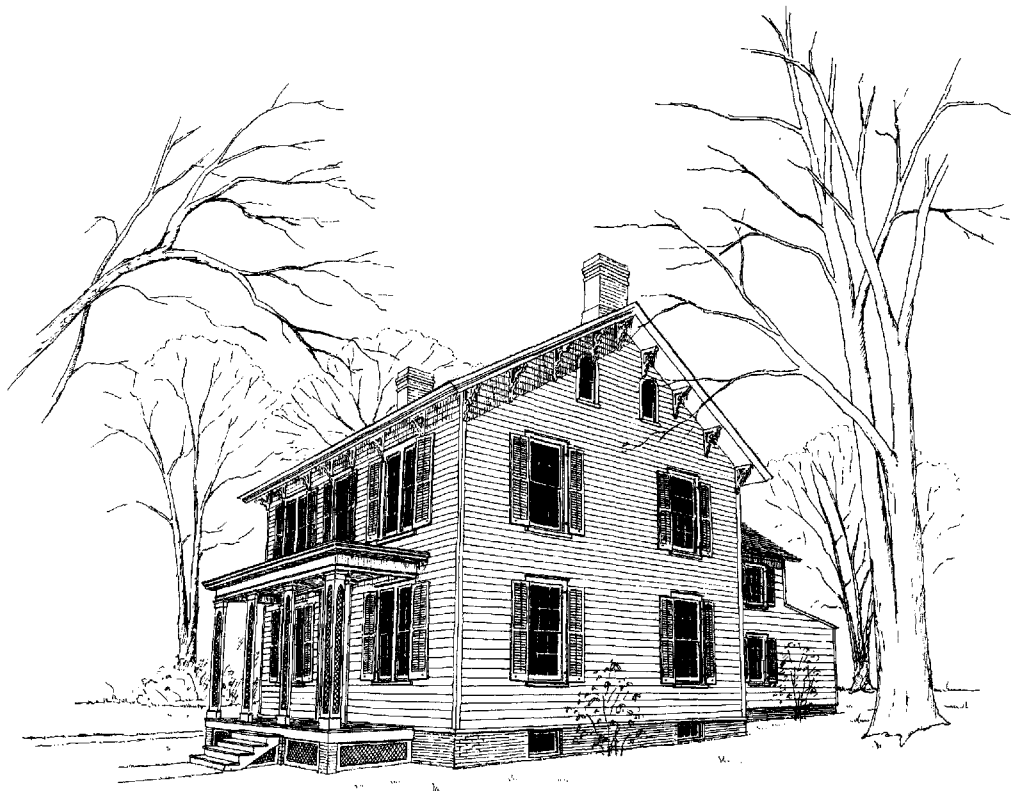
**Stephen and Charles Smith House (ca. 1860) as it appeared when built.
Porch and east ell conjectural.
Drawing by John M. Collins.**

The west front of the house, facing Bryant Avenue, is faced with a full width front porch which extends past the southwest corner of the main block of the house, and wraps around the south facade one bay. The beaded board ceiling, columns, square stock balusters and beveled top handrail all are indicative of the Colonial Revival style, and may date to the same period of interior alterations, c. 1911. The concrete steps and piers are later additions. The existing porch replaces an earlier porch which did not extend the full width of the house, as indicated by unpainted portions of the foundation.
