Roslyn Landmark Society Annual House Tour Guide.

29th Annual Tour

June 3, 1989
10:00-4:00

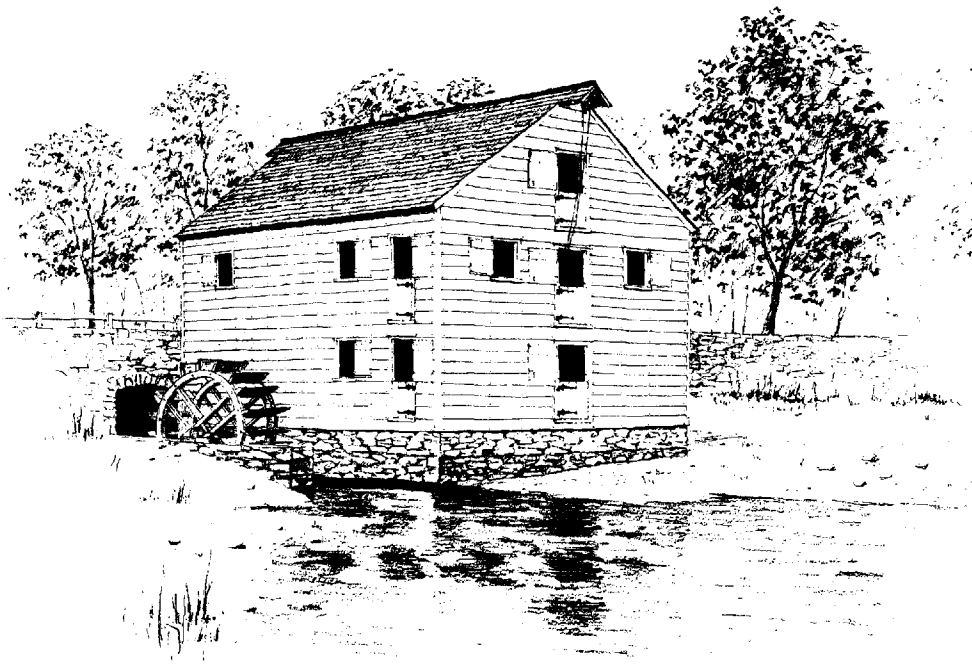
Robeson-Williams Grist Mill (1715–1740). Conjectural drawing showing original appearance of the mill. Water wheel should be of “over-shot” type.

Drawn by John Collins in 1977.

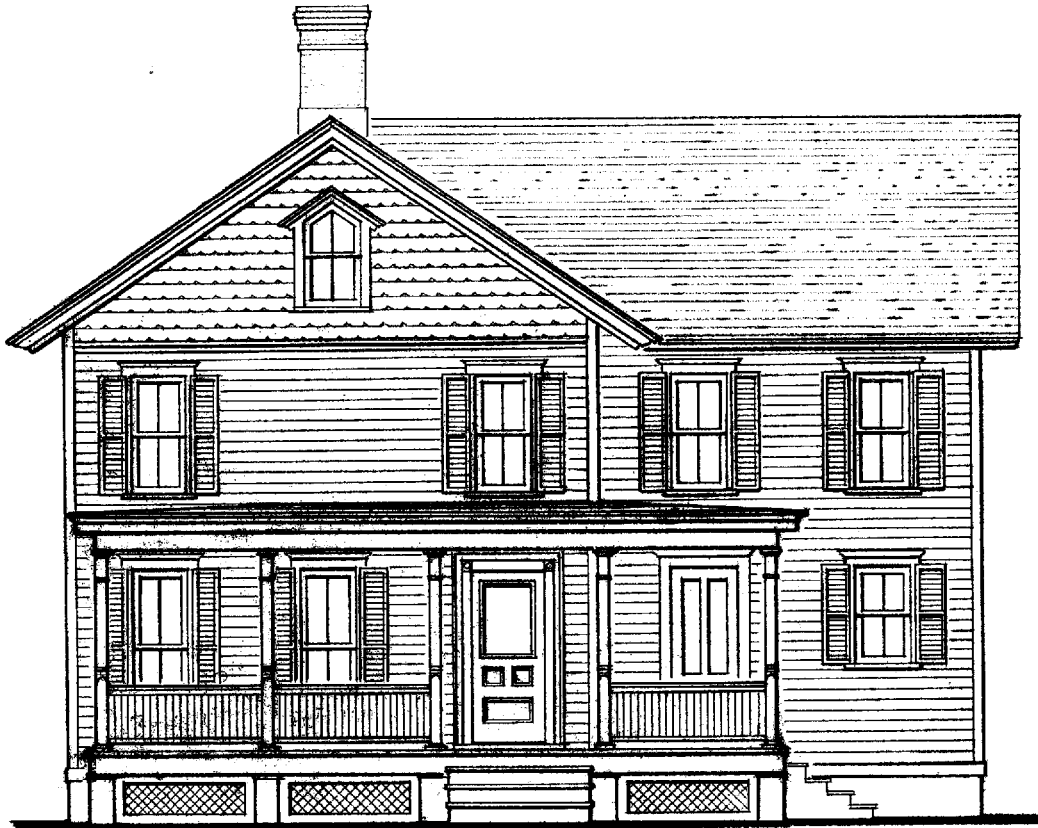
Eugene and Herbert Conklin House (1889), as it appeared after Herbert Conklin's north wing of 1907. Drawing by Cecilia Wheeler.
