Roslyn Landmark Society
Annual House Tour Guide.

34th Annual Tour

June 4, 1994
10:00-4:00

34TH ANNUAL HOUSE TOUR

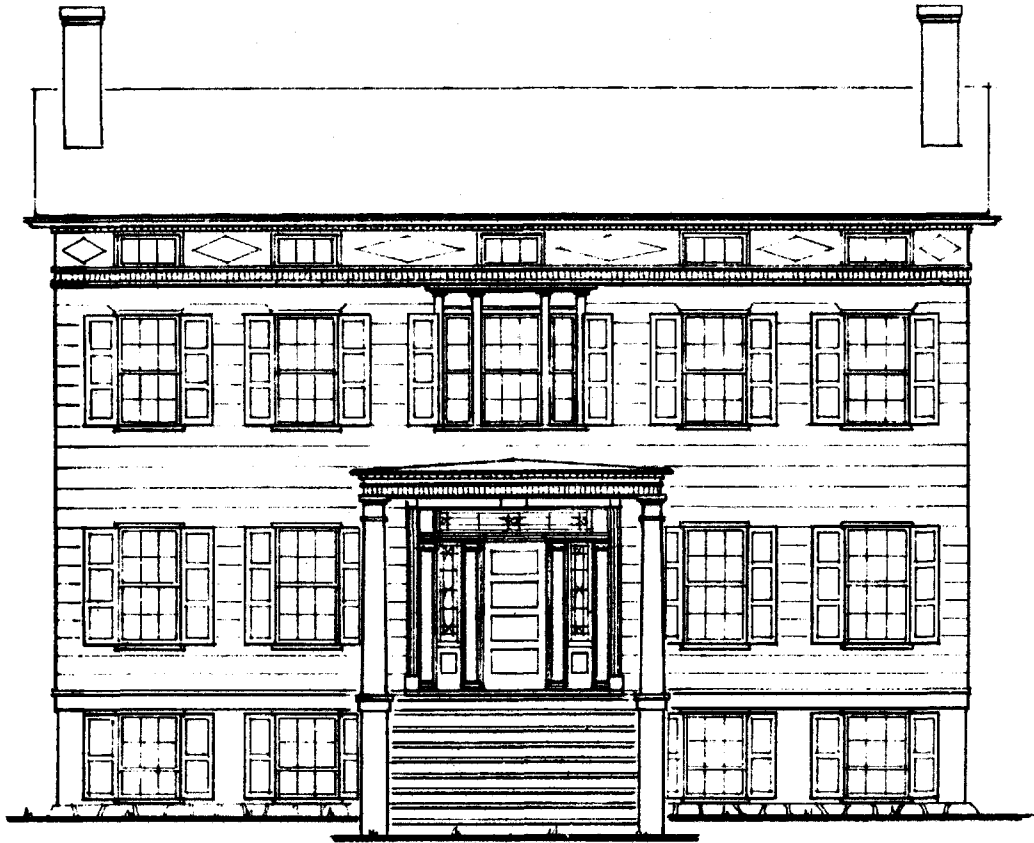
“Locust Hill”
Hendrickson-Ely-Brower House (1836)
As it appeared Ca. 1875. (Staircase is conjectural)
Guy Ladd Frost

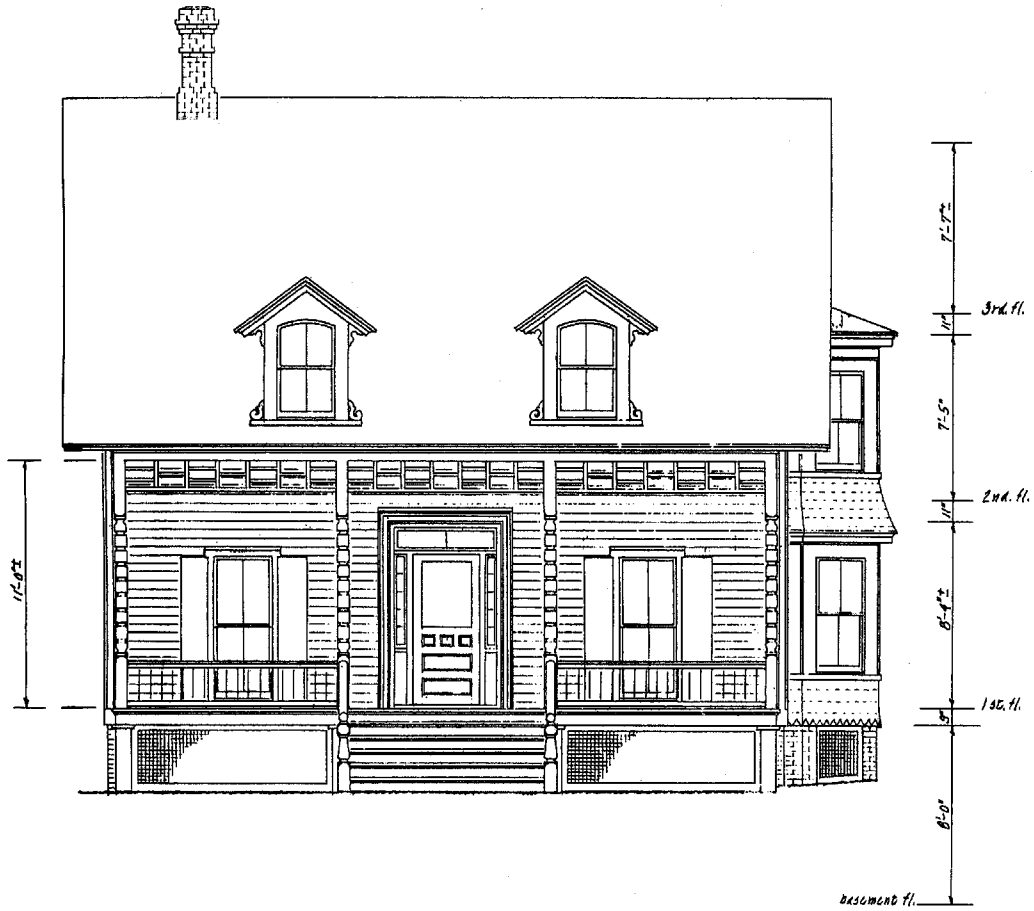
EAST ELEVATION

John F. Remsen House, 1885, as it appeared when built except that the inner core of the doorway was changed and the second storey of the bay window was added, ca. 1905.

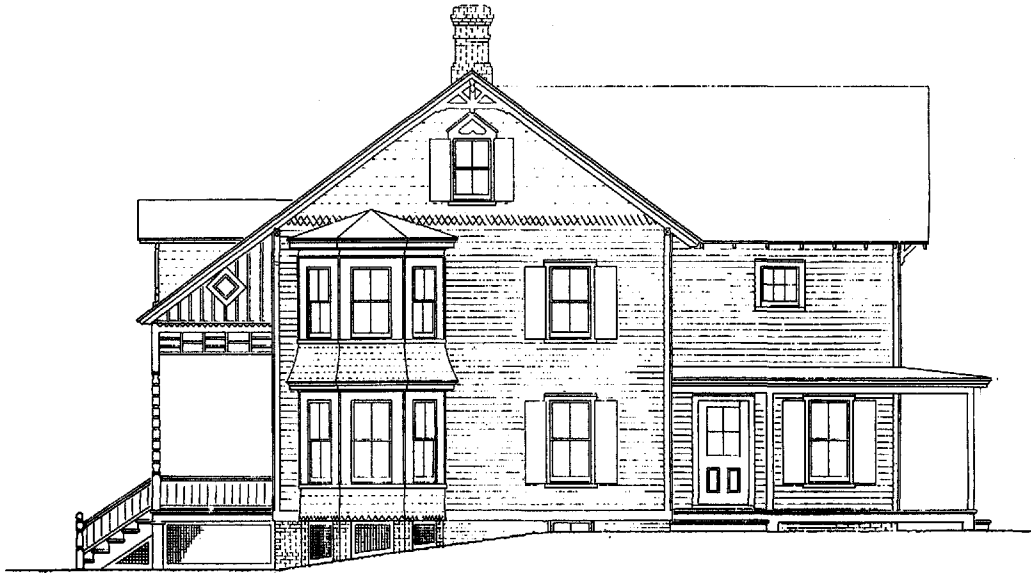
NORTH ELEVATION

John F. Remsen House, 1885, as it appeared in Phase III, ca. 1905.
Drawing by John R. Stevens.

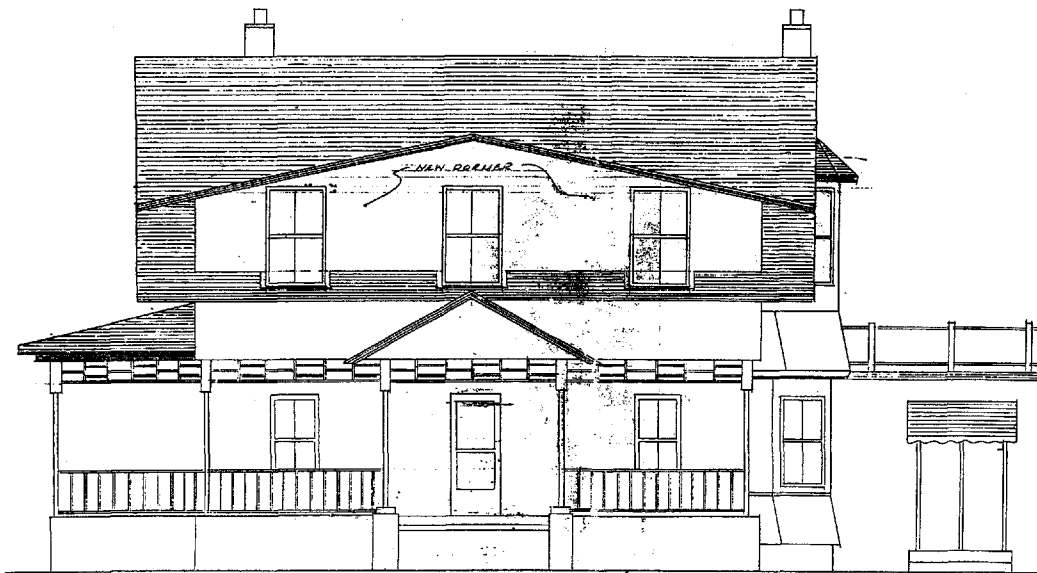
John F. Remsen House
Construction drawing for end of Phase IV, 1967.
A.J. Assocs., Huntington.

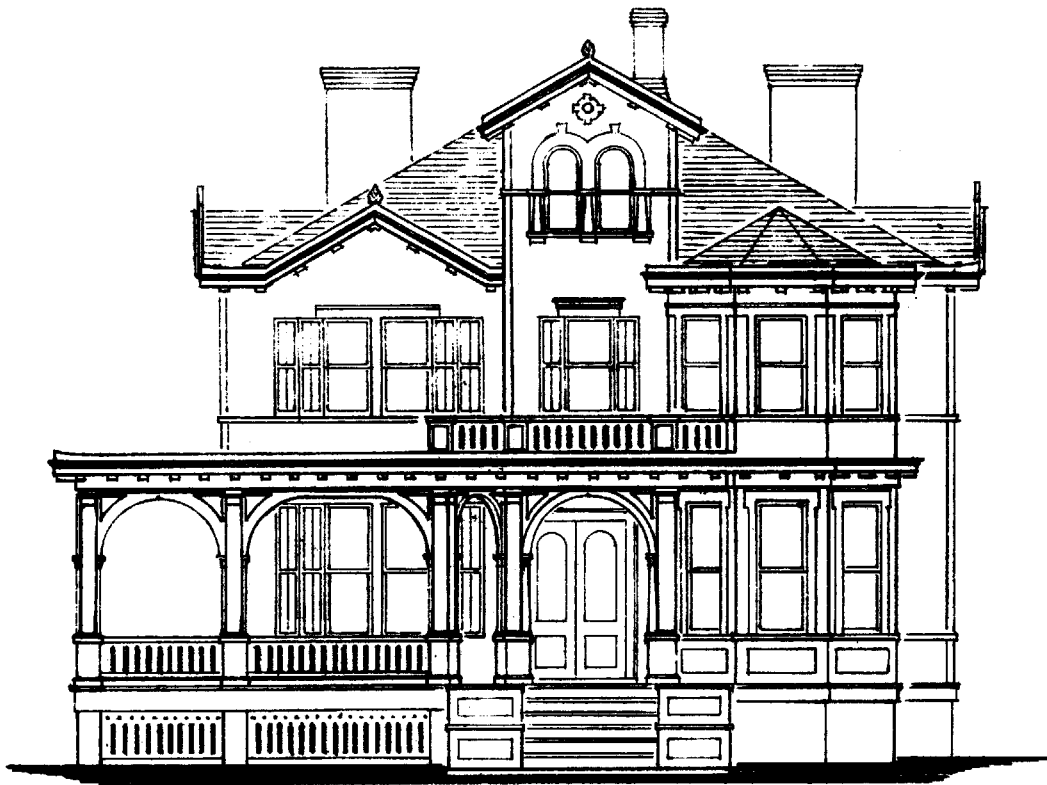
G. W. Denton House, ca. 1875
Drawn by Guy Ladd Frost, A.I.A.
